INSTALLATION RESTORATION PROGRAM

Final DECISION DOCUMENT UST SITE 1

117th Refueling Wing Alabama Air National Guard Birmingham Airport Birmingham, Alabama

January 1997

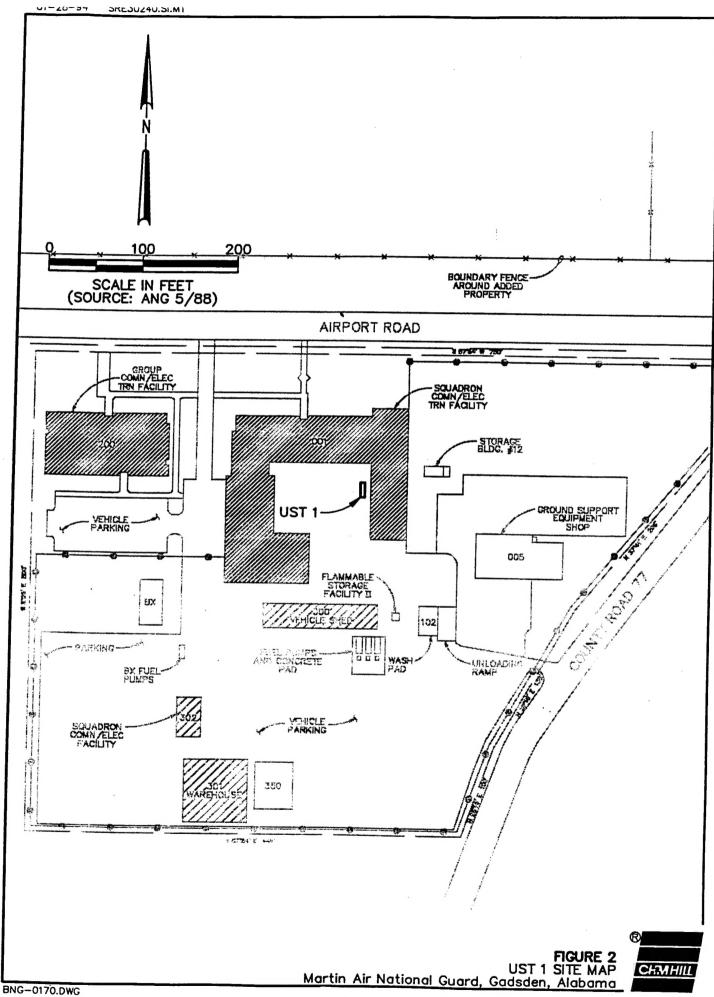
UST 1 was a 2,000-gallon fuel storage tank located next to Building 1 in the parking area. Tank age could not be determined from base records, but the estimated last use was in 1976. The tank, suspected to have contained gasoline, was removed. Figure 2 presents the UST 1 site map.

UST 1 appeared to be in good condition upon removal; no holes or corrosion were found. Soil staining was observed during the excavation and these soils were removed. The soils encountered were red to orange clayey sand overlying a gray clay. Water was encountered at a depth of 4 feet in the tank pit.
